REPORT ON RIDE-ON TYRE SEALANT 2710/C5035

Dynamic Radial Tyre Fatigue & Chemical Analysis

2710/C5035

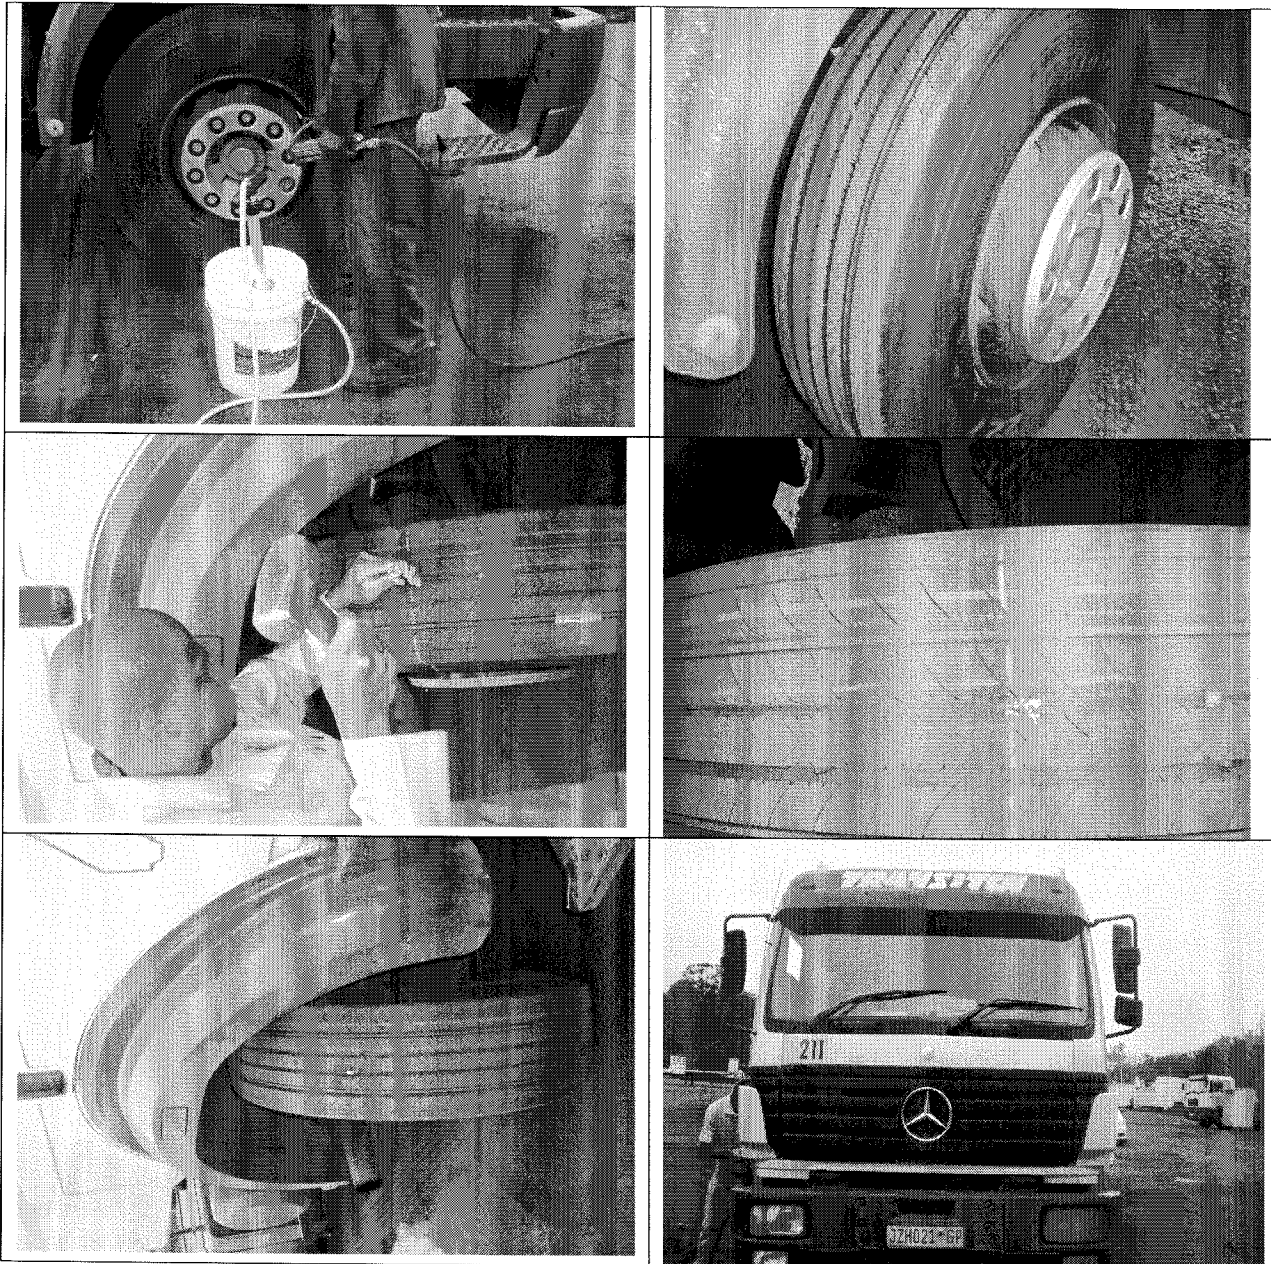
4. ANNEX 1

***FIND ATTACHED:
PHOTOGRAPHS OF TEST***

- The sample completed the required cycles and there was no air leakage during the dynamic tests.
- The tyre was then inflated to the pressure of 800 kPa for a final test (reference to clause 2.14).
- Pressure losses were experienced during static puncture operation (radial fatigue tyre, max load).
- Road test resulted in no meaningful pressure loss.
